# TECHNICAL SERVICE BULLETIN

## SP115 - Fuel Module Positioning

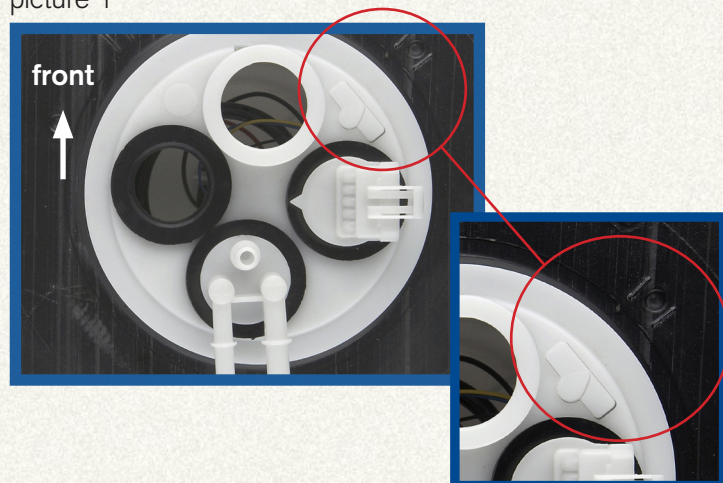
picture 1

Improper positioning of the Module in the fuel tank can lead to interference between the float and the fuel tank.

Spectra Premium Fuel Module (SP115) top cover is marked with an index arrow to ensure proper positioning. Sometimes it may be difficult to see the alignment index on the fuel tank due to external contamination. If such is the case, follow the guidelines mentioned below in this document to ensure proper Fuel Module positioning and accurate fuel level readings. (Picture 1)

Ensure that the Fuel Module alignment index is properly positioned with the fuel tank alignment index. If the fuel tank alignment index is not visible, ensure the Fuel Module is positioned as per the reference marks relative to the front and rear of the vehicle. (Picture 1)

NOTE: After final tightening of lock ring, ensure that the alignment of the module did not move out of position.

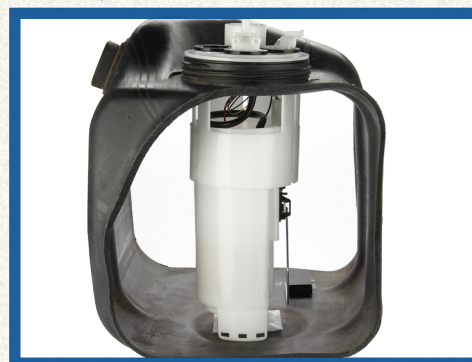
correct position
